DEPARTMENT OF TRANSPORTATION

Quality Assurance and Source Inspection

Contract #: 04-0120F4Cty: SF/ALA Rte: 80 PM: 13.2/13.9File #: 69.28**WELDING INSPECTION REPORT****Resident Engineer:**Siegenthaler, Peter**Address:** 333 Burma Road**City:** Oakland, CA 94607**Report No:** WIR-021680**Date Inspected:** 07-Mar-2011**Project Name:** SAS Superstructure**OSM Arrival Time:** 700**Prime Contractor:** American Bridge/Fluor Enterprises, a JV**OSM Departure Time:** 1900**Contractor:** Zhenhua Port Machinery Company, Ltd (ZPMC), Changxing Island **Location:** Shanghai, China**CWI Name:** An Qing Xiang.**CWI Present:** Yes No**Inspected CWI report:** Yes No N/A**Rod Oven in Use:** Yes No N/A**Electrode to specification:** Yes No N/A**Weld Procedures Followed:** Yes No N/A**Qualified Welders:** Yes No N/A**Verified Joint Fit-up:** Yes No N/A**Approved Drawings:** Yes No N/A**Approved WPS:** Yes No N/A**Delayed / Cancelled:** Yes No N/A**Bridge No:** 34-0006**Component:** OBG components.**Summary of Items Observed:**

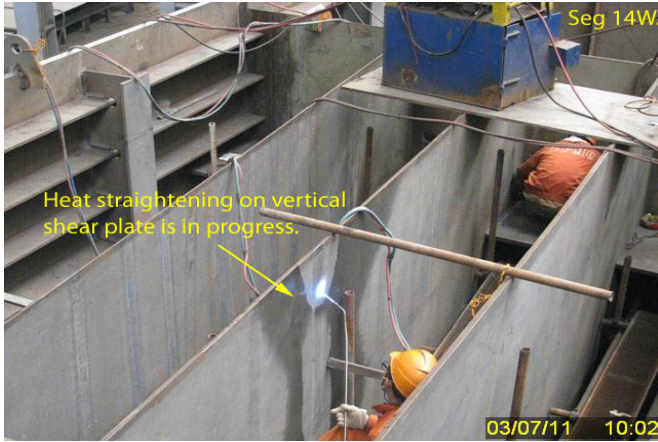
This QA Inspector observed ZPMC personnel performing heat straightening on Sub Assembly Vertical Shear Plate (VSP). Heat straightening was done as per heat straightening report (HSR): 10156. See attached photo for further information.
